## Maintenance of Traffic

### Interstate 70 Overlay Project

Ellsworth and Lincoln Counties, Kansas

#### Project Overview

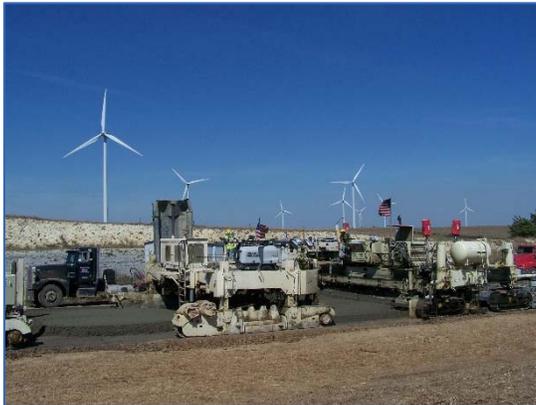
- As mainline paving was performed, Koss had to mill 2 ft of the 10 ft. shoulder, making it difficult for trucks to navigate around the paving train. With the existing slope grade constantly changing, the contractor used millings to stabilize the outer edge.
- Close communication also kept crews and the public safe in and around the construction workzones.

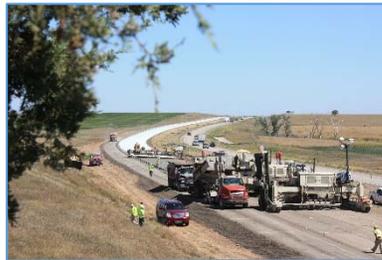
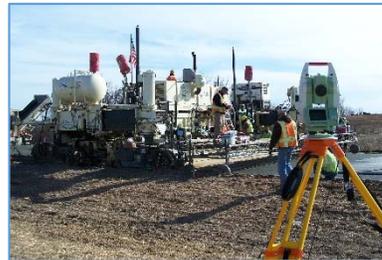
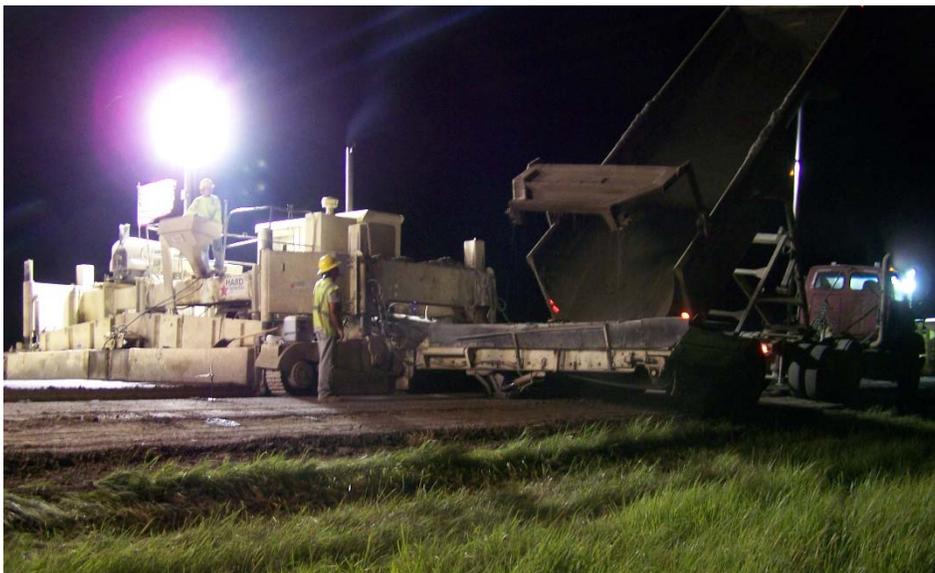
- A highly experienced crew was selected for this job, which helped achieve a very smooth pavement with an average profile index of 9.2 in. per mi.
- Concrete paving was done in 30-ft wide passes. Koss requested and received approval to insert tie bars mechanically, including some of the centerline tie bars, which were placed using a tie-bar inserter built by Koss mechanics.
